**REMOVAL ASSESSMENT REPORT  
FOR THE  
BAKER PERKINS SITE  
SAGINAW, SAGINAW COUNTY, MICHIGAN**

**NPL STATUS: NON-NPL**

**U.S. ENVIRONMENTAL PROTECTION AGENCY**  
Emergency Response Branch  
Region V  
9311 Groh Road  
Grosse Ile, MI 48138-1697

**WESTON SOLUTIONS, INC.**  
6779 Engle Road  
Suites I & J  
Middleburg Heights, OH 44130

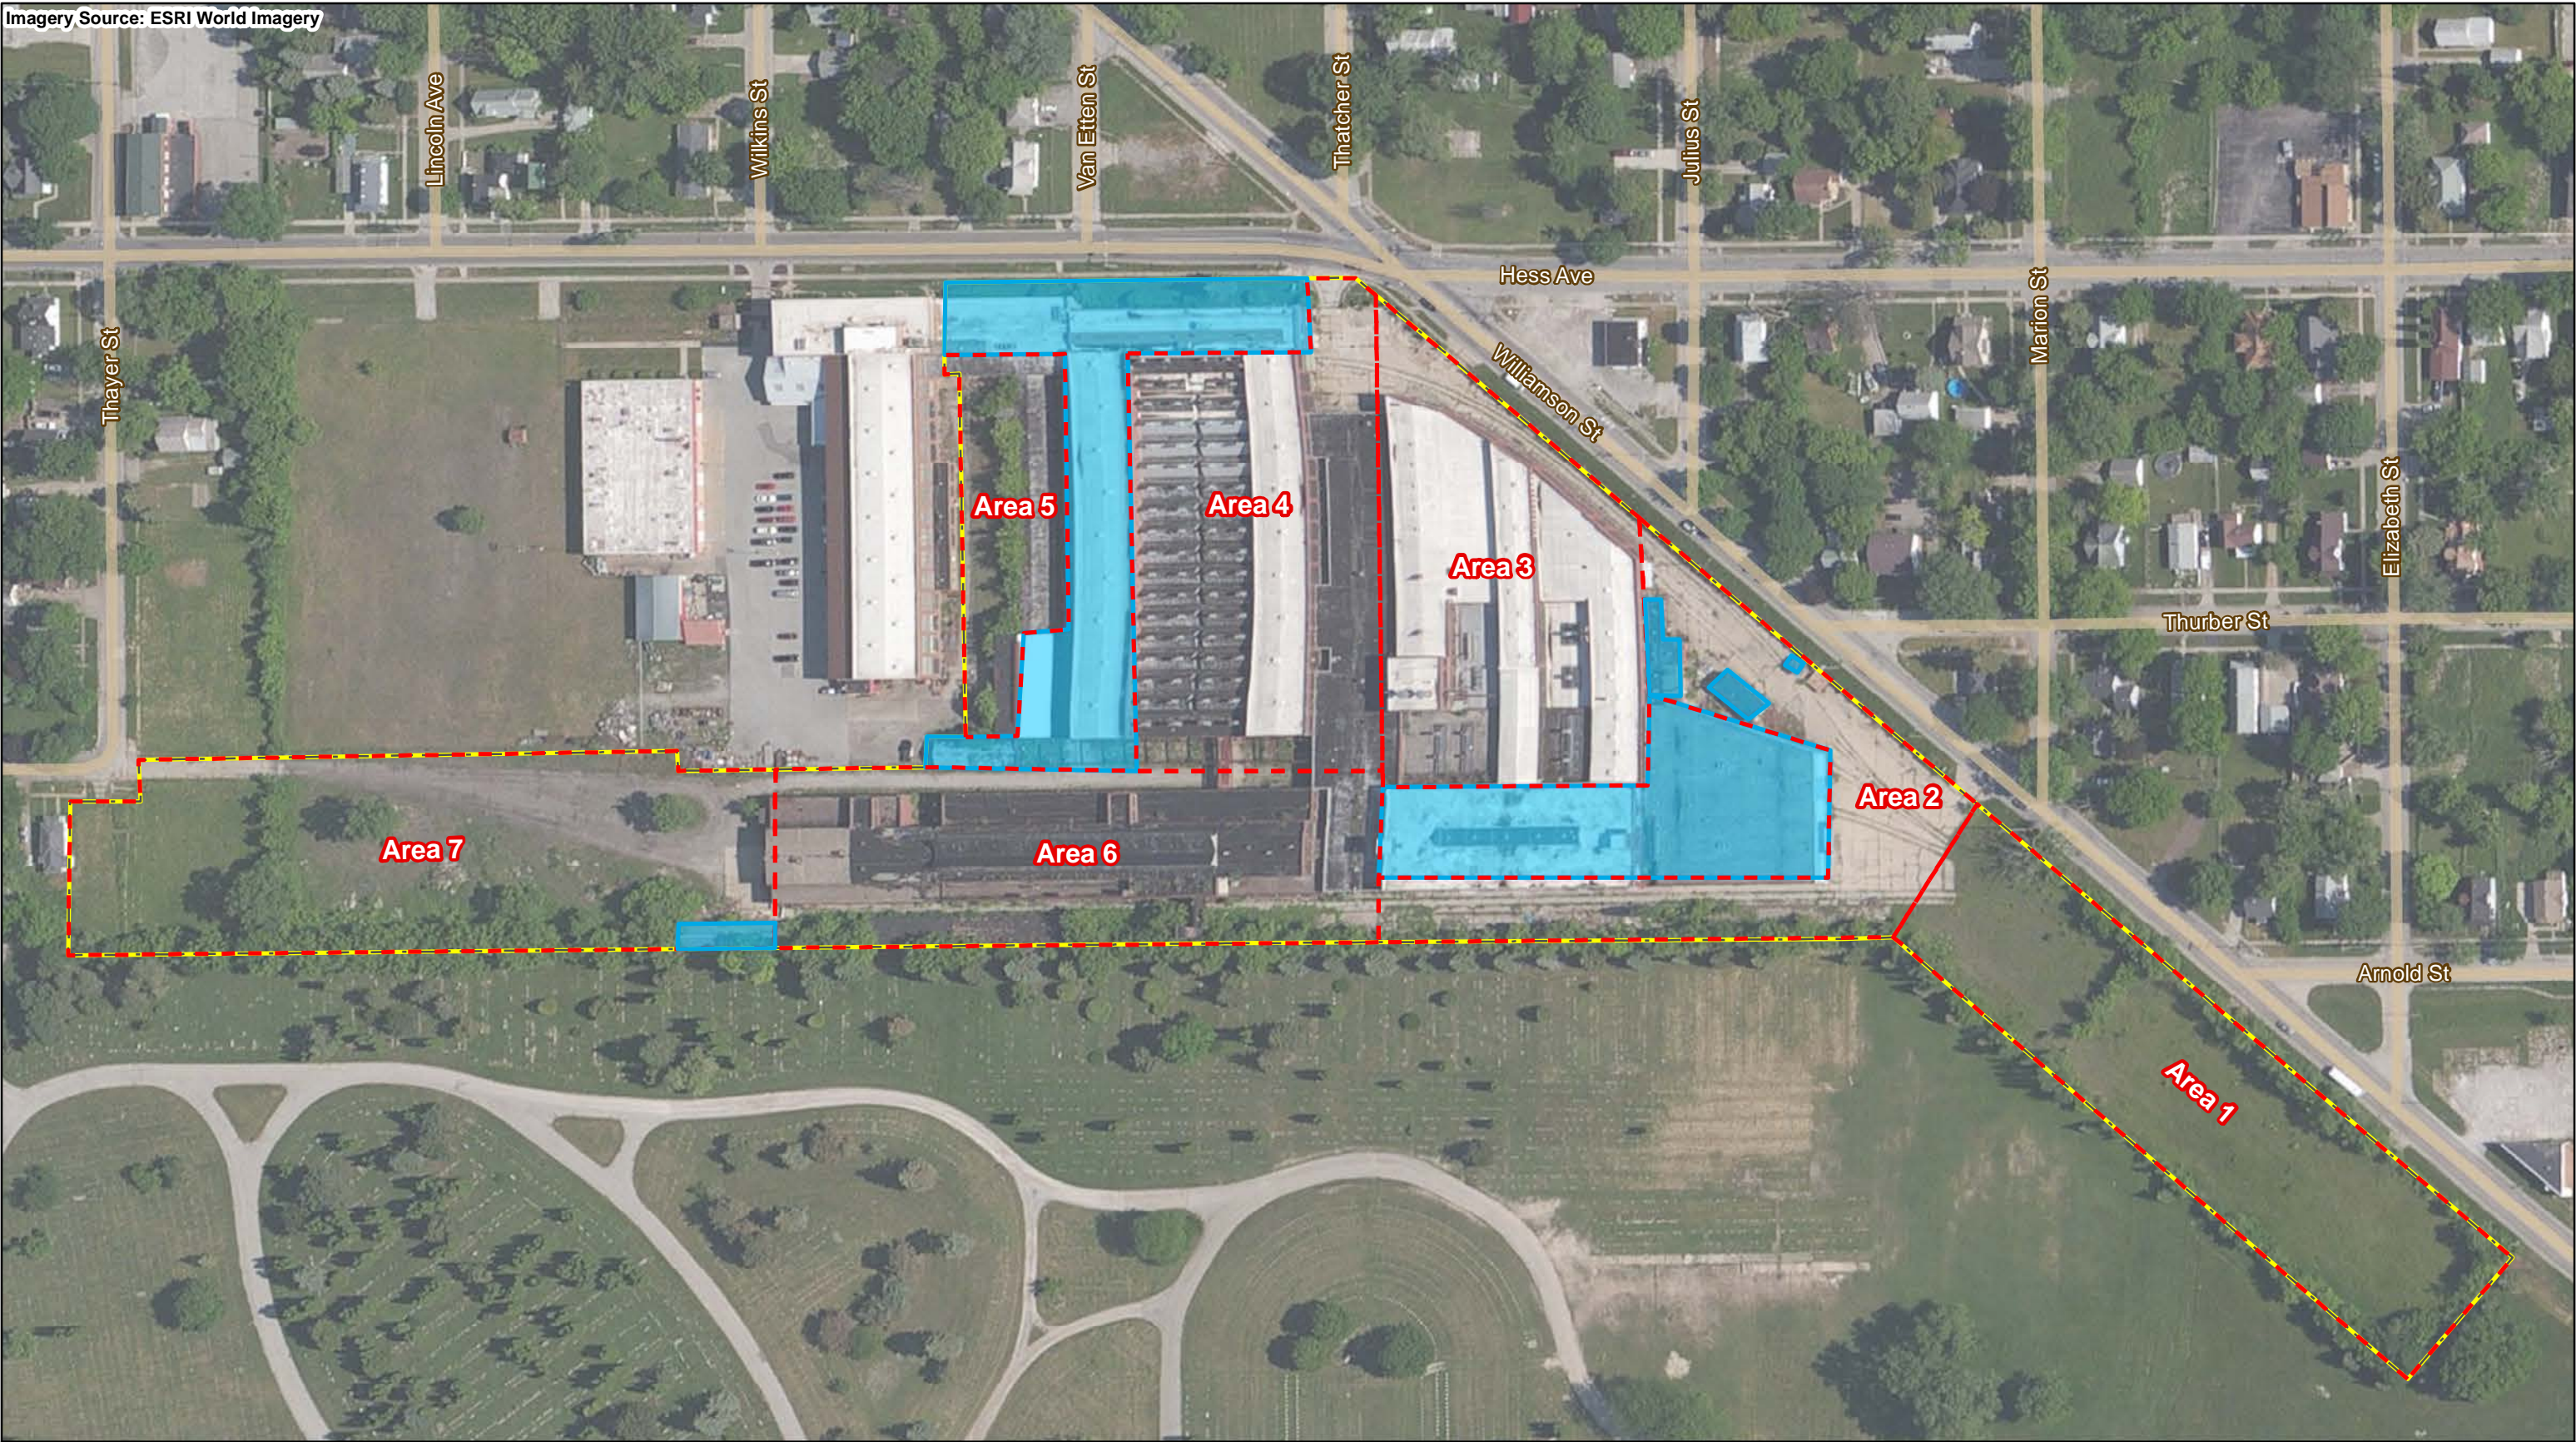
**Figure 2**  
Site Features Map  
Baker Perkins Site  
Saginaw, Saginaw County, Michigan

Most buildings appear to have been demolished in-place. Many demolition debris piles remained within the footprints of the former buildings. Three small stockpiles of scrap metal were observed in open areas between the debris piles in Areas 3 and 4. During the Removal Assessment, it was apparent that most of the salvageable metallic building materials had been segregated from the debris piles during the demolition process and removed from the Site for metal scrapping. Many manhole covers also were missing at the Site and presumably have been removed for metal scrapping.

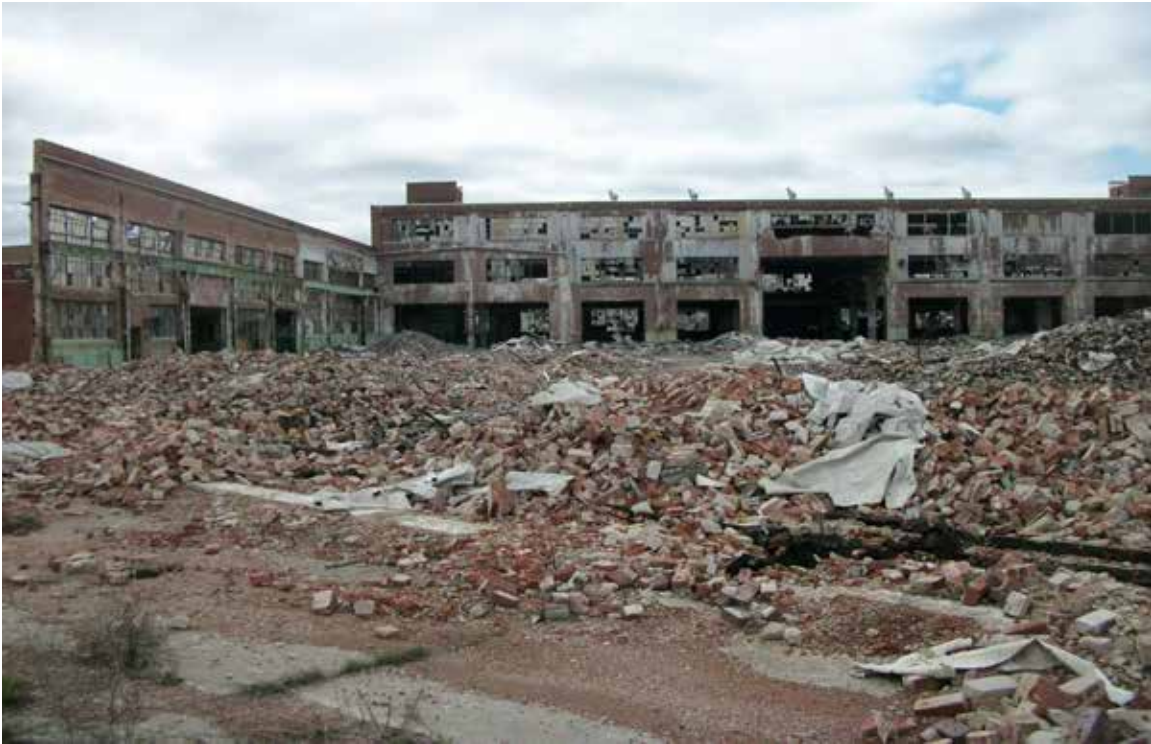
**Site:** Baker Perkins  
**Photograph No.:** 1  
**Direction:** South  
**Subject:** Demolition debris piles in Area 3

Track marks from heavy equipment were observed on top of the demolition debris piles containing ACM, suggesting that ACM building materials were not handled properly during demolition activities and may have been crushed and damaged. No visible signs of off-site migration of suspected ACM were observed during the Removal Assessment.

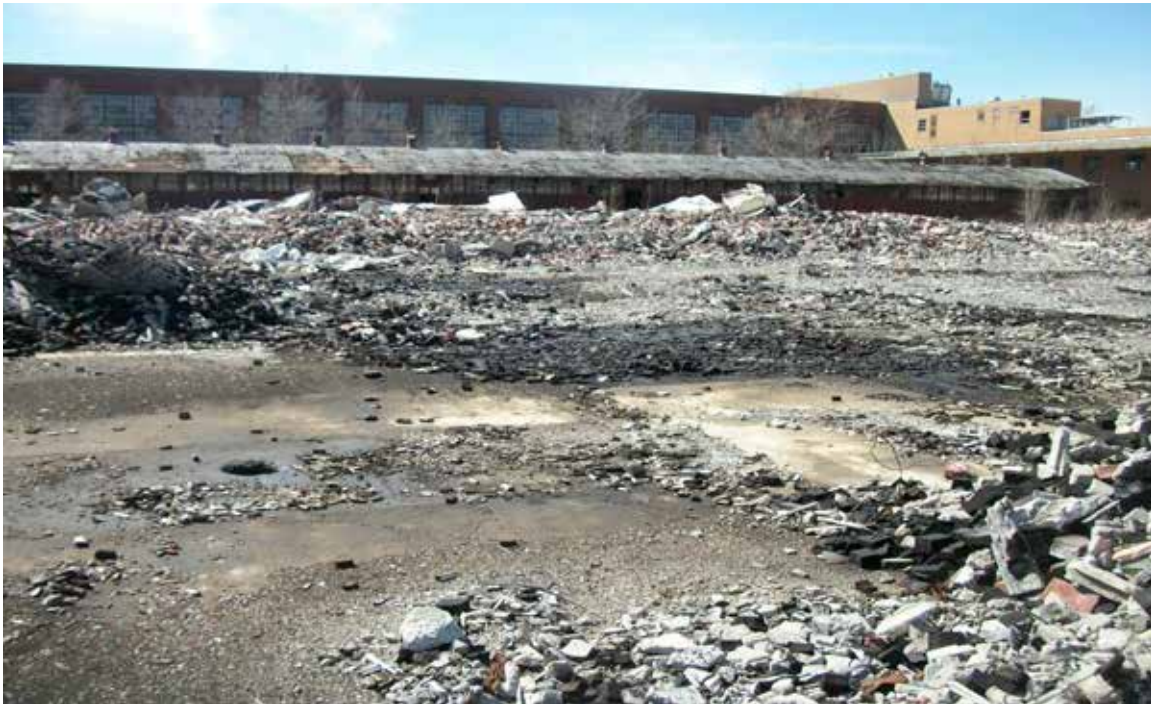
**Photograph No.:** 17

**Subject:** Area 4 location from which wood block flooring sample BP-WB-02 was collected

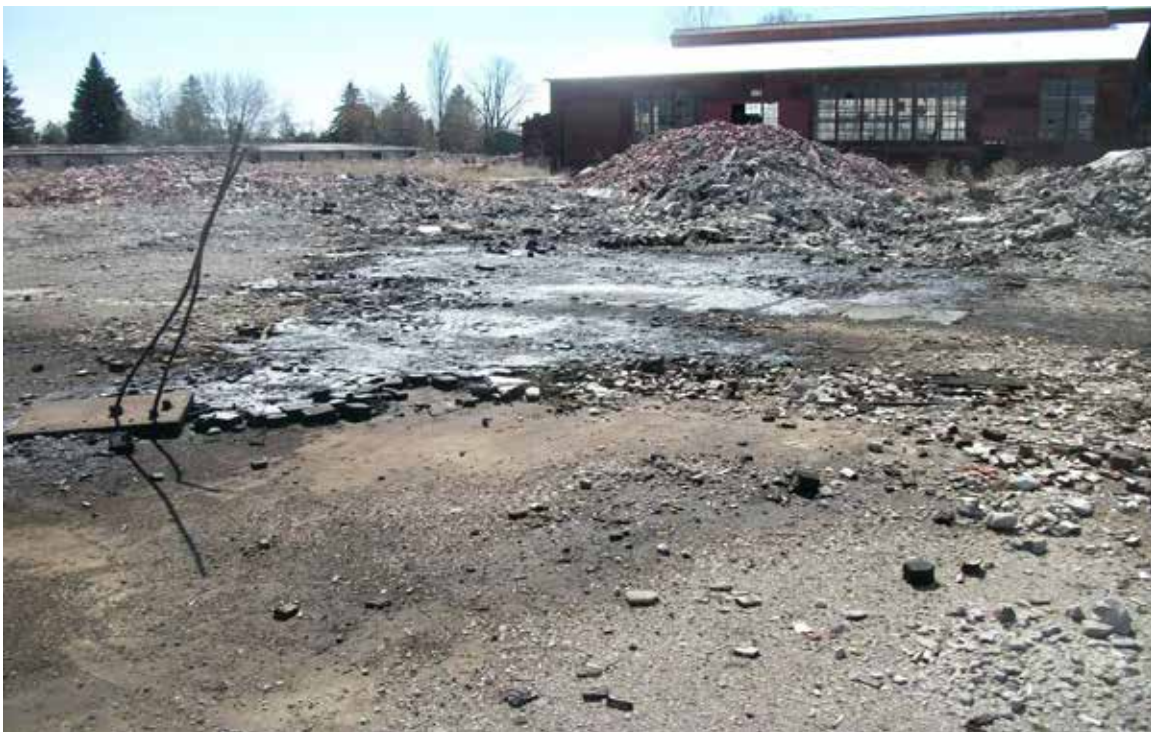
**Photograph No.:** 18

**Subject:** Area 4 location from which wood block flooring sample BP-WB-03 was collected

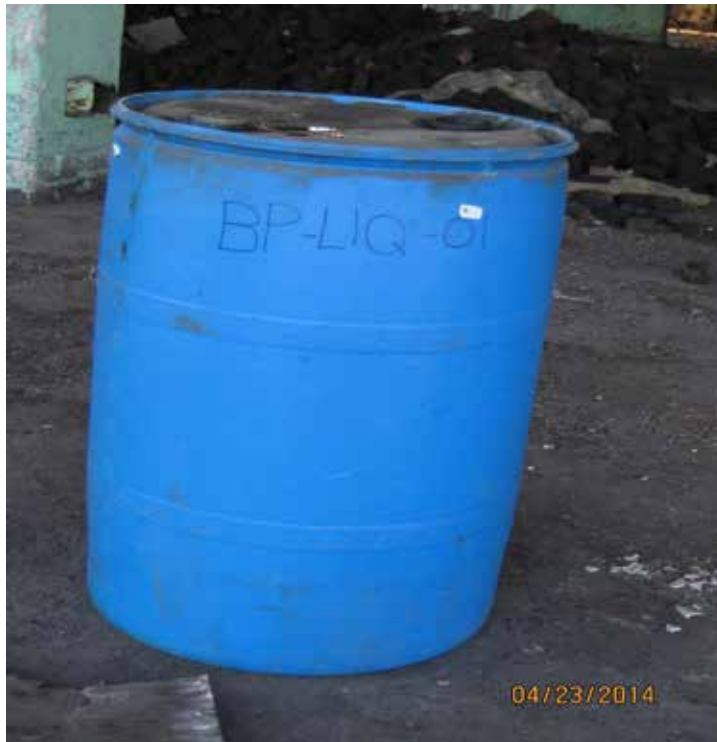
**Photograph No.:** 21

One unlabeled 55-gallon polyethylene drum was located on the ground floor of the building south of Area 3. The drum contained approximately 35 gallons of what appeared to be oil, and there were no signs of oil staining on the ground surface near the drum. Sample BP-LIQ-01 was collected from this drum for laboratory analysis.

**Subject:** Oil sample BP-LIQ-01 collected from plastic drum inside building south of Area 3

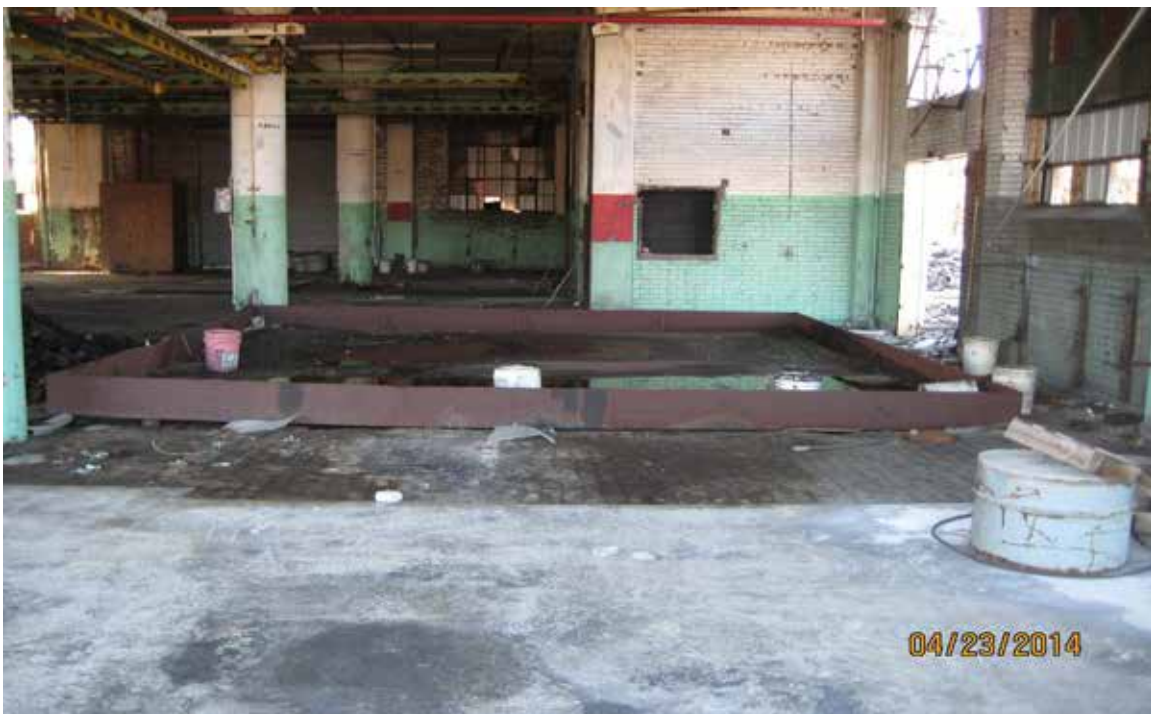
**Photograph No.:** 22

Seven 5-gallon containers were found on the ground floor of the building south of Area 3. These small containers were partially filled with liquid and located inside steel secondary containment.

A small quantity of standing water with a sheen on the surface was observed on the floor of the secondary containment. Two of the 5-gallon containers were labeled "Benchmark F-126-M (CL-11)," a cleaning compound. Another two of the 5-gallon containers were labeled "Milicron," a concentrated metal working fluid. One 5-gallon container was labeled "Chemtool Incorporated Stripper Additive." The last two 5-gallon containers either were not labeled or the label was too damaged to read. These small containers were not opened or sampled during the Removal Assessment.

**Subject:** Small containers and secondary containment in building south of Area 3
